Manhole Inspection Summary

Manhole # S45KK_016MH

Insp Date: **2/22/10 12:30 PM**

Location Address: **1721N. Wolfe St.**

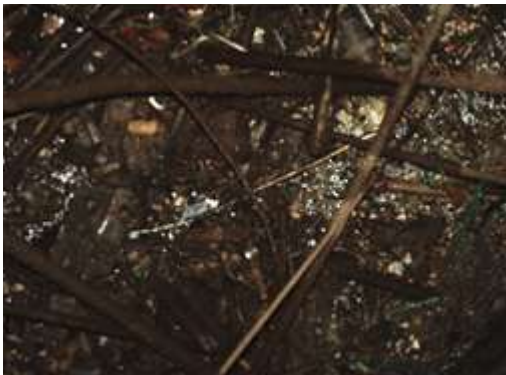
Defect 3

Condition: ☐ Sound ☐ Cracked ☐ Root Intrusion ☐ Deteriorated ☐ Leaks ☒ **Debris**

debris

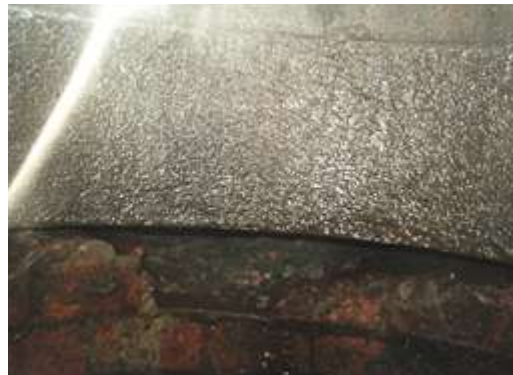
Defect 2

☒ **Leaks**

frame leaks

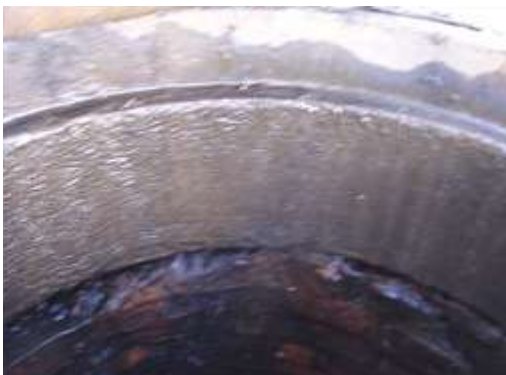
Defect 1

frame leaks

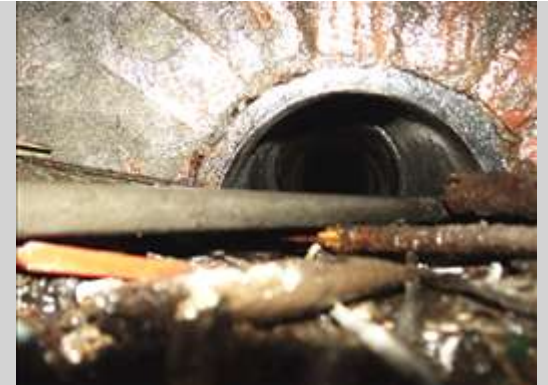
12 O'Clock Outflow

Deposits: ☐ None ☐ Mud ☐ Sludge ☒ **Debris** ☐ Grease

Silt Depth: **3** (in.) Deposits Extent: **Heavy**
